**IN THE UNITED STATES DISTRICT COURT
FOR THE SOUTHERN DISTRICT OF TEXAS
GALVESTON DIVISION**

No. 3:19-cv-207

**MEMORANDUM OPINION AND ORDER
ENTERING FINDINGS OF FACT AND
CONCLUSIONS OF LAW**

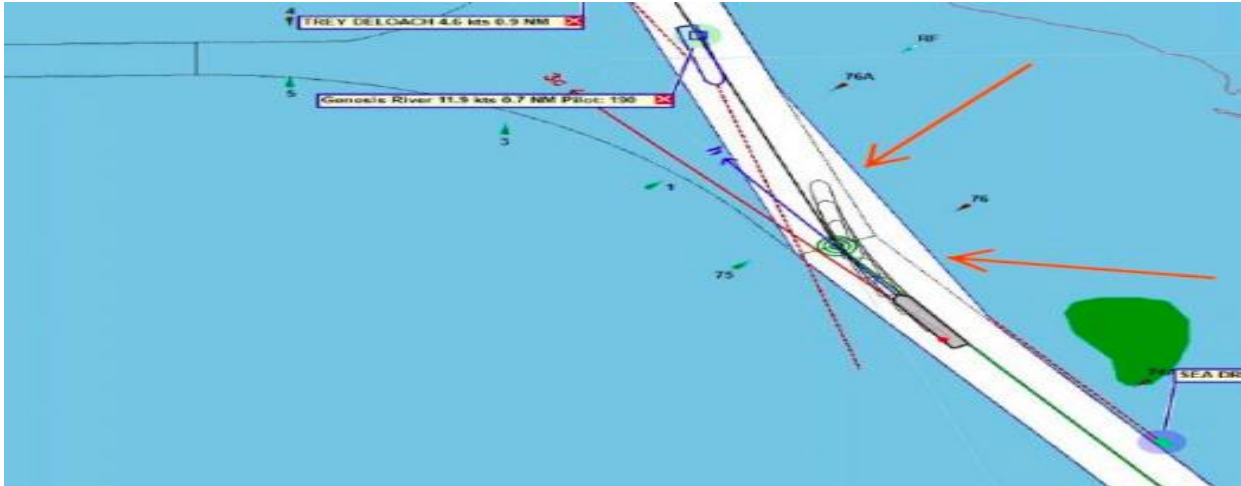
Figure 5. Widener at the Bayport Flare

The Bayport Flare is a highly trafficked area near the intersection of the Houston Ship Channel and the Bayport Channel. To accommodate the high traffic and promote safer meetings between ships in the area, a “widener” has been

dredged at the elbow of the channel, which provides an additional width of suitable water depth for inbound vessels.

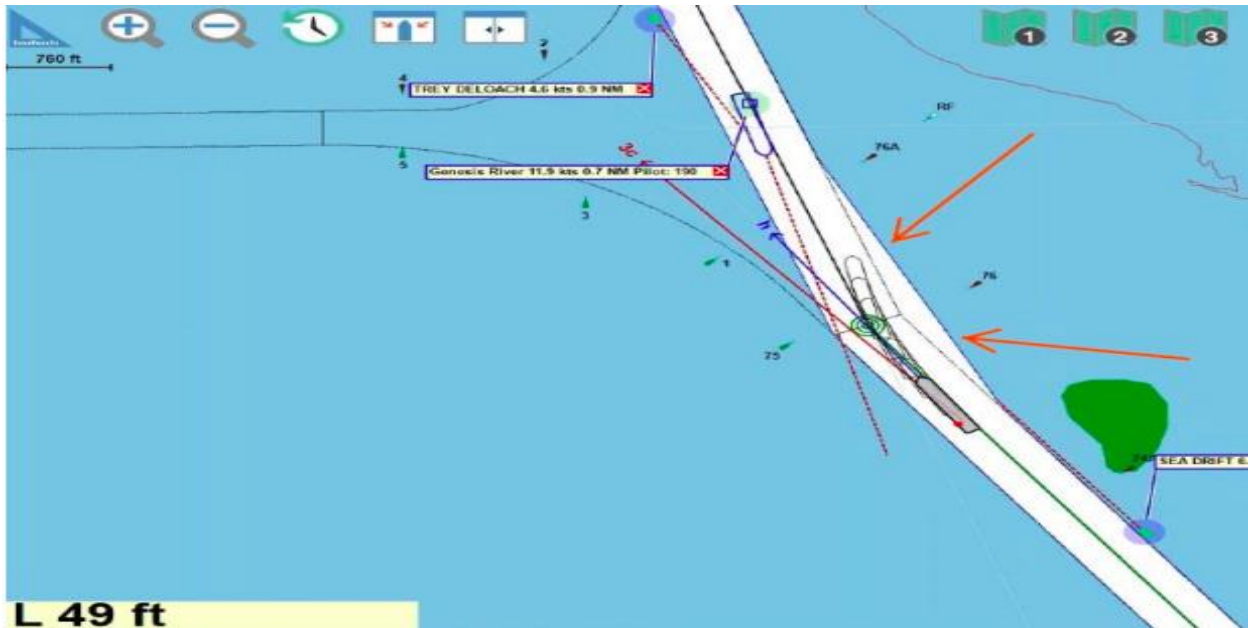
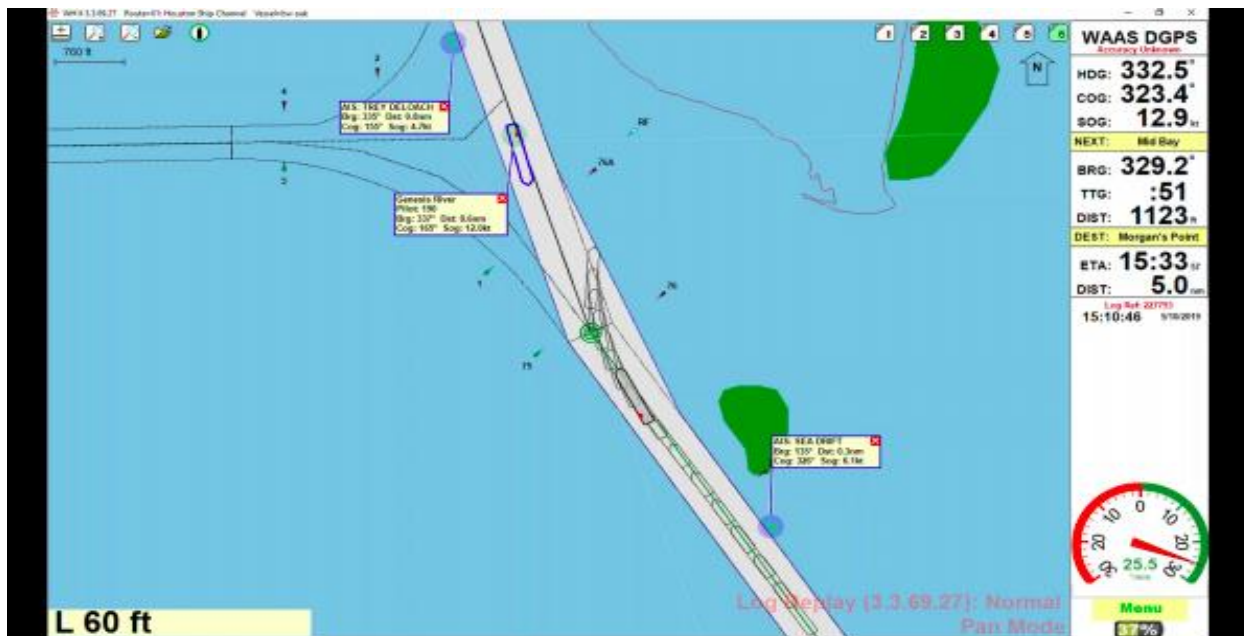
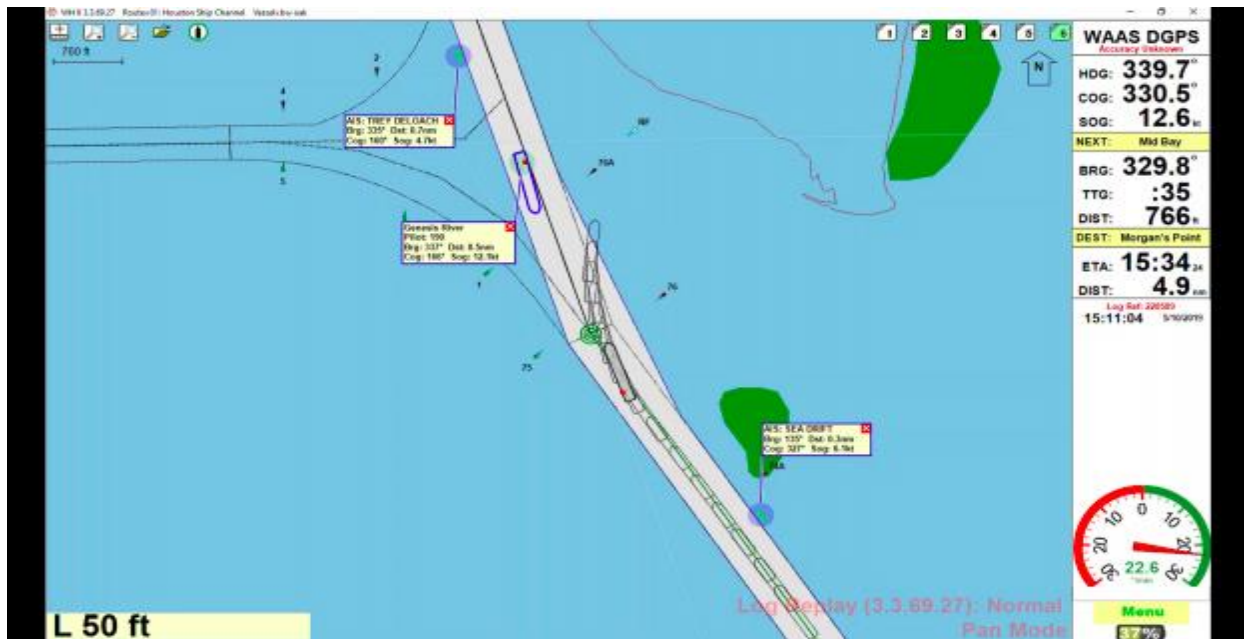
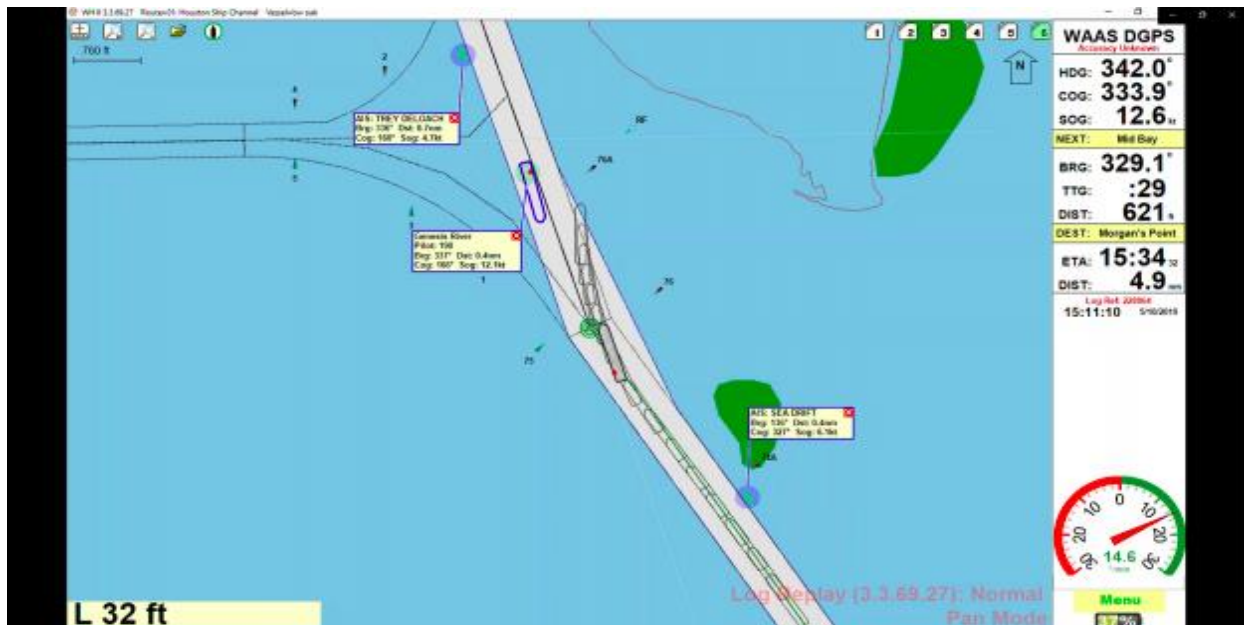
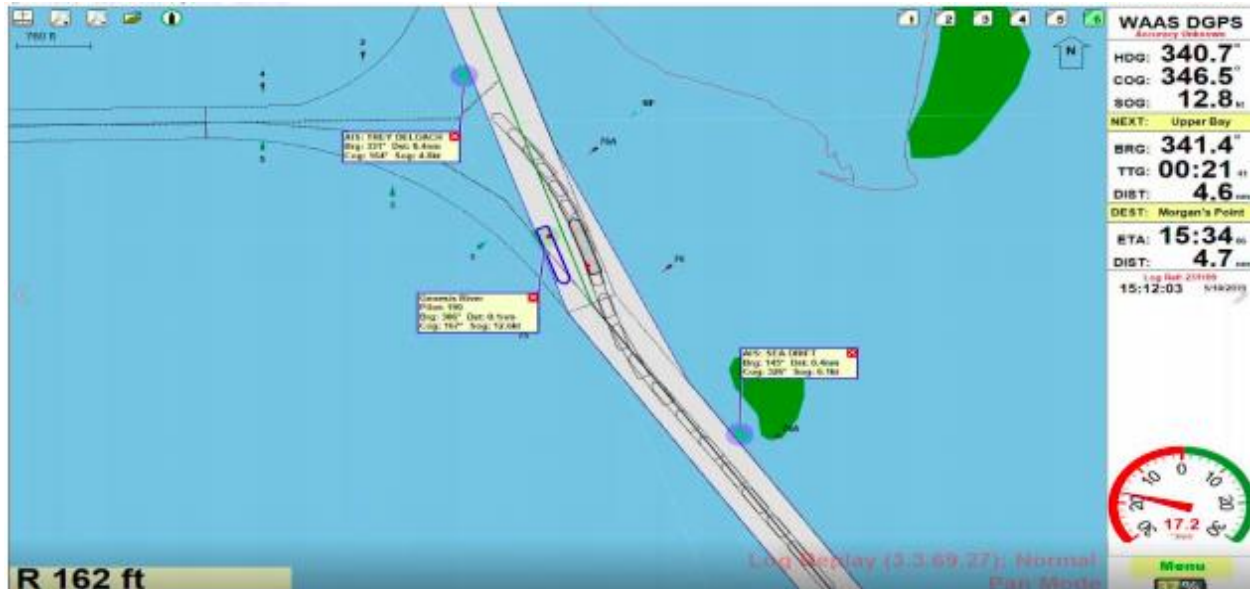
Soon, the swiftly cruising, fully loaded vessel was approaching the *BW Oak* near the Bayport Flare. When the vessels were about a mile apart, they agreed to a port-to-port, one-whistle passing (*i.e.*, a passing in which the vessels stay in their respective right-lane positions). To execute this passing arrangement, they used the “centerline approach,” or “Texas chicken,” which begins with each vessel navigating along the channel’s centerline.³ Then, once they are within about a half mile, each turns to the starboard side to prepare to pass the other. This maneuver facilitates a safe passing because the hydrodynamic forces acting on the vessels as they pass stern to stern help them re-align in the center once the passing is complete.

Around the time the two vessels agreed to this passing, the *BW Oak* was preparing to make a starboard turn at the flare. As she did, her stern swung out slightly to the port side, crossing the centerline by 49 feet.

³ Figures 6–12 illustrate the passing of the *Genesis River* and the *BW Oak*. The ship descending from the top of each illustration is the *Genesis River*; the one moving up from the bottom is the *BW Oak*.

In making the turn at the flare, Captain Barton opted against steering the *BW Oak* through the widener on the red side. If he had, Captain Barton testified, the two vessels would have been temporarily pointing directly at each other, an “uncomfortable” heading for them both.

By the time the *Genesis River* and the *BW Oak* closed to within a half mile, the *BW Oak* had completed her turn at the flare. She had then moved 134 feet to the right of the centerline, comfortably on the red side.

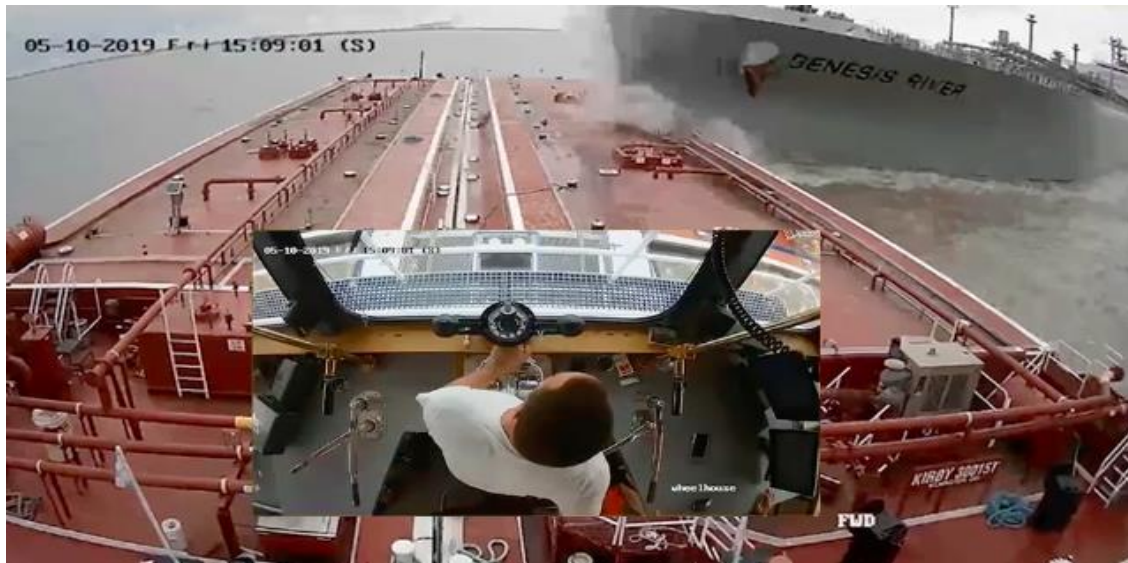
While Captain Marie tried to move the *Voyager* to the green side, the *Genesis River* crossed the channel's centerline and entered the barge lane where the *Voyager* had been. Had the *Genesis River* maintained this new position on the red side of the channel, she would have complied with the new starboard-to-starboard agreement. But, as Captain Charpentier predicted, she did not. Shortly after she darted to the red side of the channel, the *Genesis River* took yet another sheer, which sent her back toward the green side where the *Voyager* had fled.

Both Captain Marie and Captain Charpentier now realized that a collision was certain. Seconds after the vessels' crews braced for impact, the *Genesis River's* bow sliced into one of the barges (the *Kirby 30015T*), nearly cutting her in half, and reformat gushed into the channel. The force of the impact also caused the other barge (the *MMI 3041*) to capsize. Fortunately, though the damage to the vessels was great and the spill catastrophic, there was no loss of life.
